BUREAU OF SHIPS GROUP  
TECHNICAL INSPECTION REPORT

⑥ OPERATION CROSSROADS.  
U.S.S. GASCONADE (APA 85).

TEST BAKER.

VOLUME 1 [U] ⑧

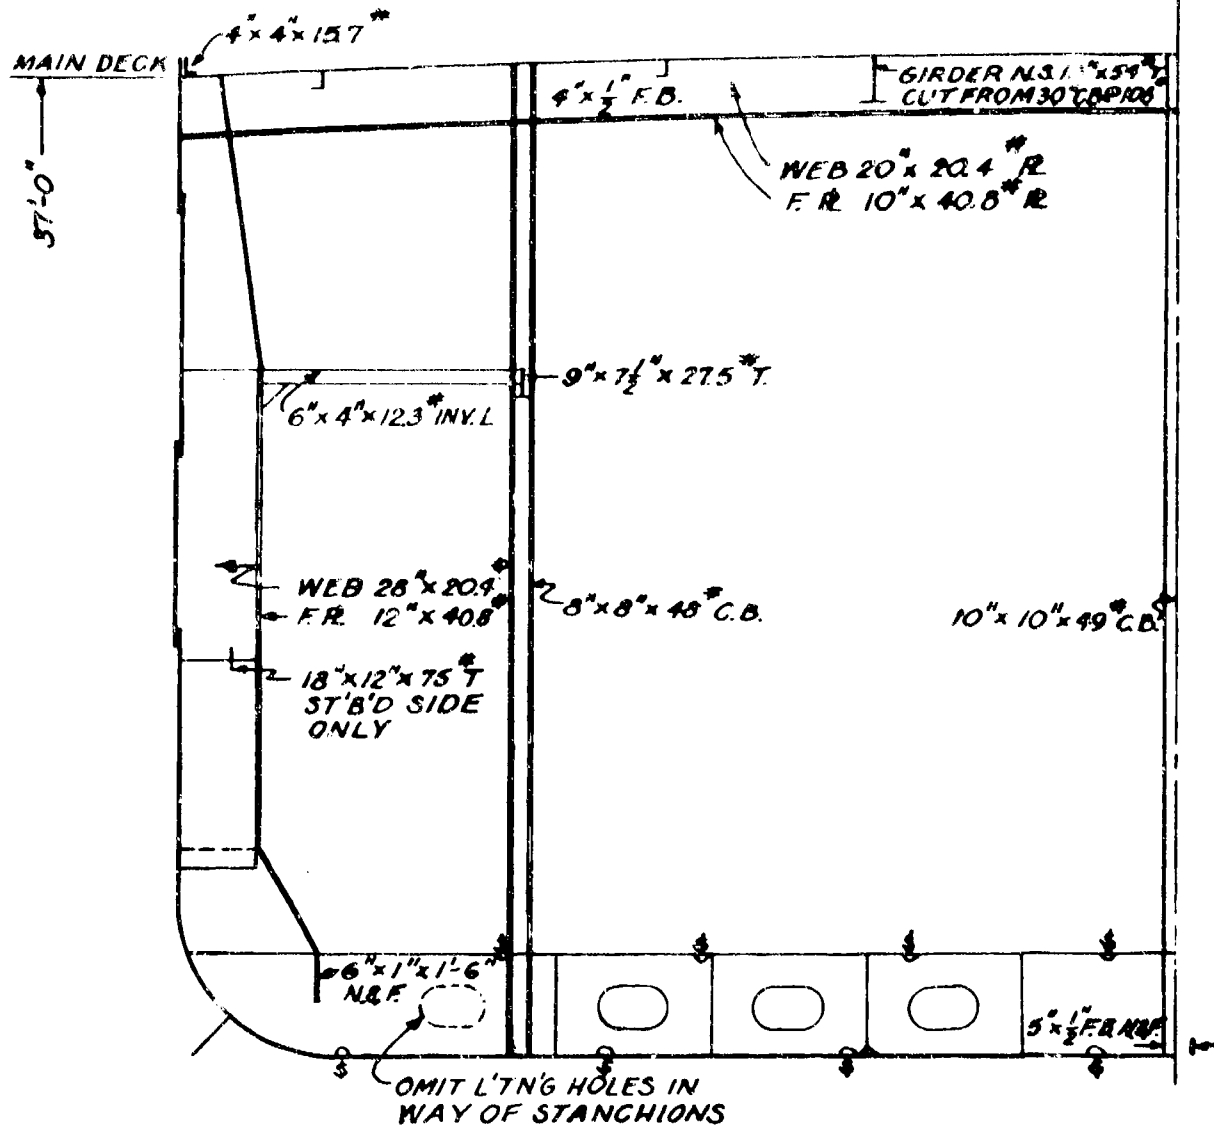
FRAME 76 LOOKING AFT  
MIDSHIP SECTION  
TEST B

The most significant damage is a wrinkle in the shell at frame 95. It runs downward from just below the port sheer strake, under the bottom, and up, almost to the starboard sheer strake. The bottom is further wrinkled between frames 80 and 81 and frames 111 and 113. There is also panel dishing of the bottom from frames 75 to 115. Part of the port and starboard bilge keels are missing. The starboard shaft fairwater is separated from the hull. There is considerable dishing of topside doors and light metal structures and distortion of below decks metal joiner bulkheads. Ladder pins are sheared and handrails are broken. Platforms in the after machinery space in way of frames 94-95, port and starboard, are badly wrinkled. Centerline stanchions at frames 76 and 101 in the machinery spaces, show compression stress patterns. Several bulkheads are wrinkled and watertight doors are sprung.
